## Residential Septic System Failure and Rehabilitation with Vacuum Bubble<sup>®</sup> Technology (VBT<sup>™</sup>) - A Case Study

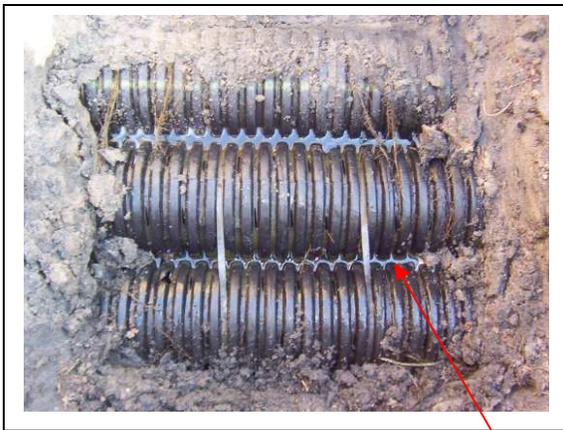
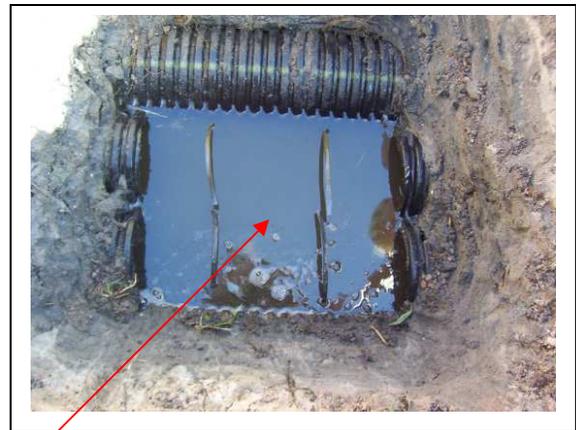
Inspection ports were installed on the header and footer of the system and it was found that the drainfield was totally flooded.

Flooded Drainfield

The solution was the installation of a Model 101 VBT™ unit in the septic tank to recover the system (Florida Department of Health (FDOH) approved drain field repair). The VBT™ was installed in a float kit that allows for fluctuations in water levels in the tank without the risk of the motor running dry or of being submerged. The total cost of the installation was less than half the cost to replace the drainfield.

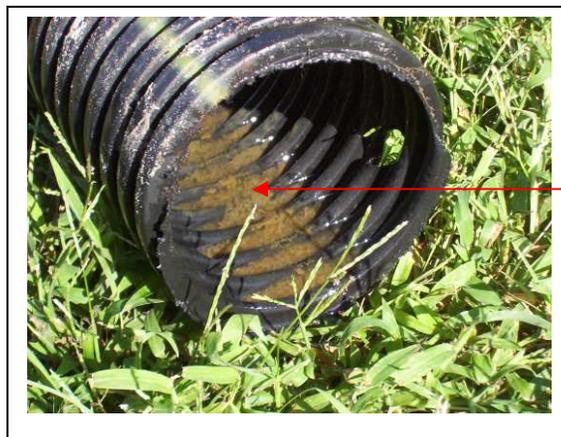
Yellow slime and flocculant material in pipe

On excavation of a 12" x 12" section of the center of the drainfield the pipes were found to contain a yellowish slime and flocculant material. A sample of the raw water from the tank was taken and the results showed 0.25 mg/L of hydrogen sulfide and a pH of 7.41.

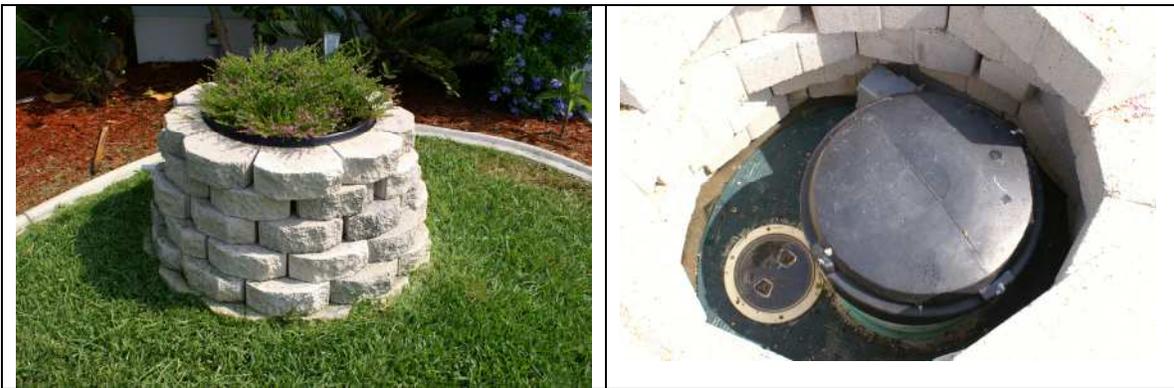
Views of the VBT™ installed in the float kit in the tank

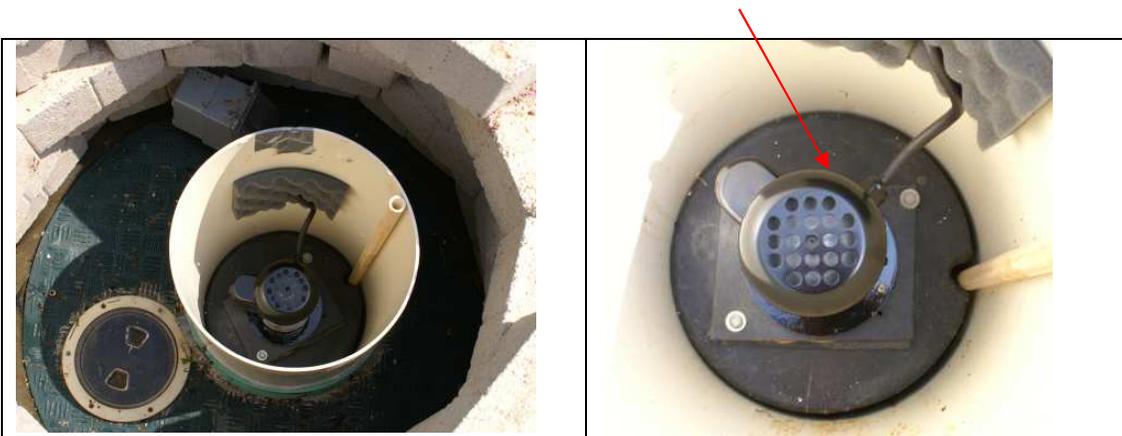
VBT™ located on the float

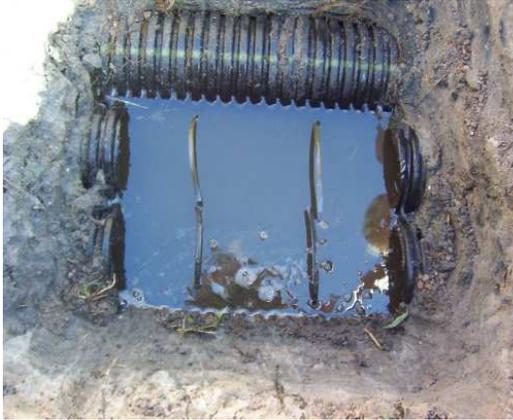
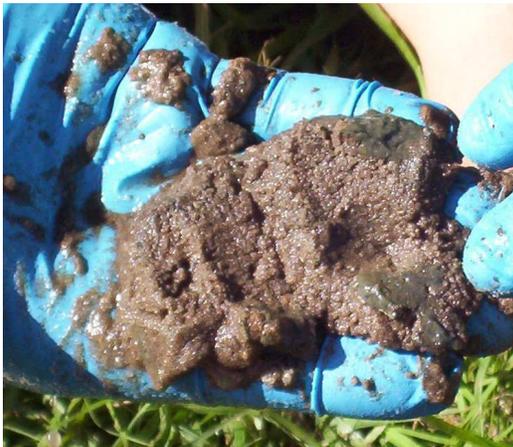
Before

Soil/sand samples from the drainfield showing loss of porosity and biomat loading

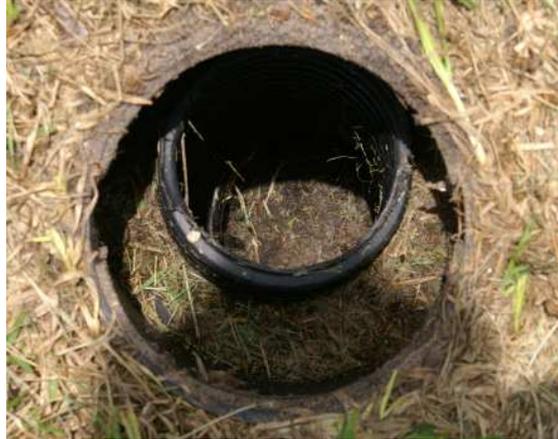
Sight tube at upper layer of ADS multi-pipe system.

Drainfield dry after installation of VBT™.

After four months of operation of the Model 101 VBT™, the drainfield at the upper level of the ADS multi-pipe system, and at the top of the palmdale sand was completely dry. The thick scum layer on the top of the septic tank was reduced to a thin layer that

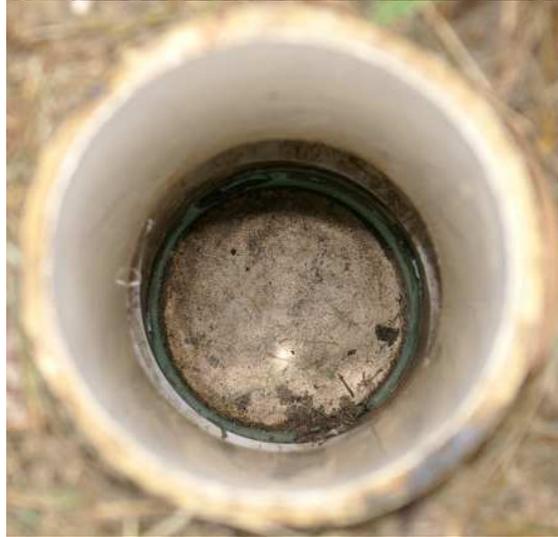
Sight tube view of palmdale sand at base of ADS multi-pipe system.

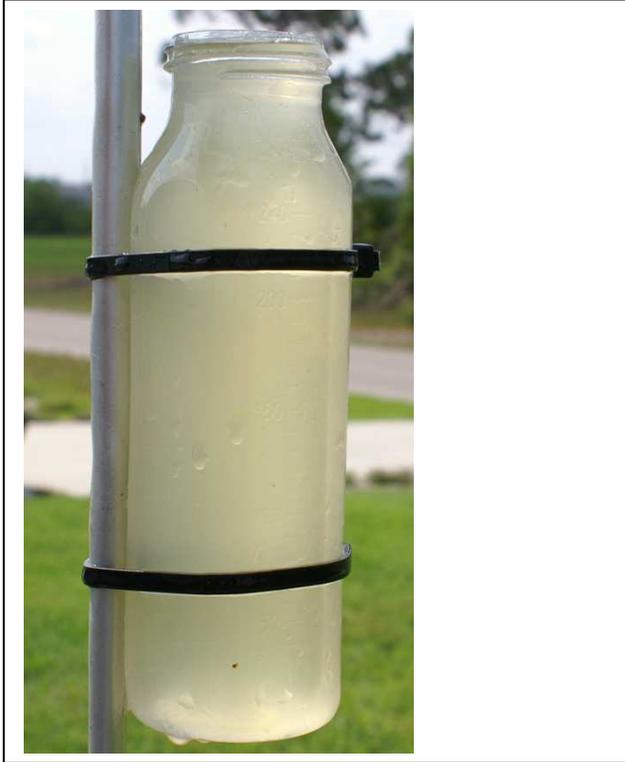
## Improved water quality after installation of VBT™
