Endurance Test of Vacuum Bubble[®] Technology (VBT[™]) Aerator - A Case Study

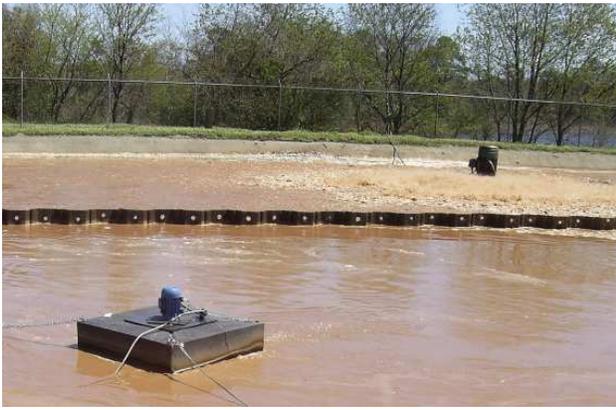
VBT™ and Surface Aerator in Oxidation ditch

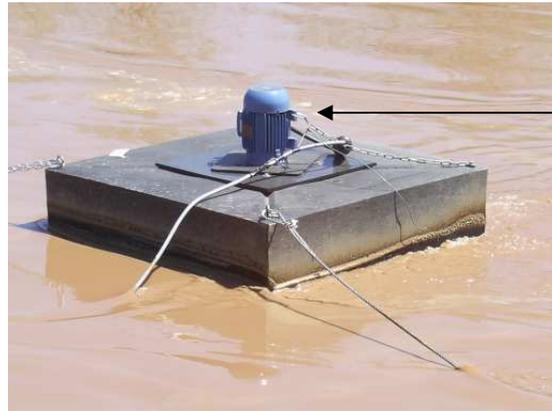
VBT™ on Float
in
Oxidation Ditch
